ERDC TR-01-8

Development of a Geomorphology-Based Framework for Cultural Resources Management, Dworshak Reservoir, Idaho

August 2001

Final report

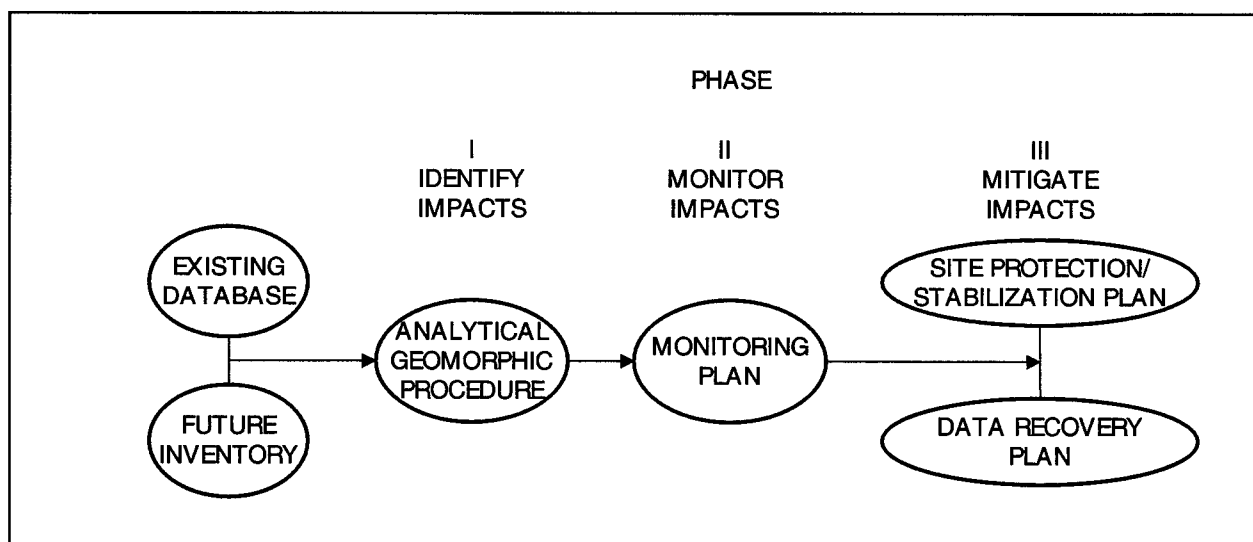
Figure 1. Technical framework of the management process

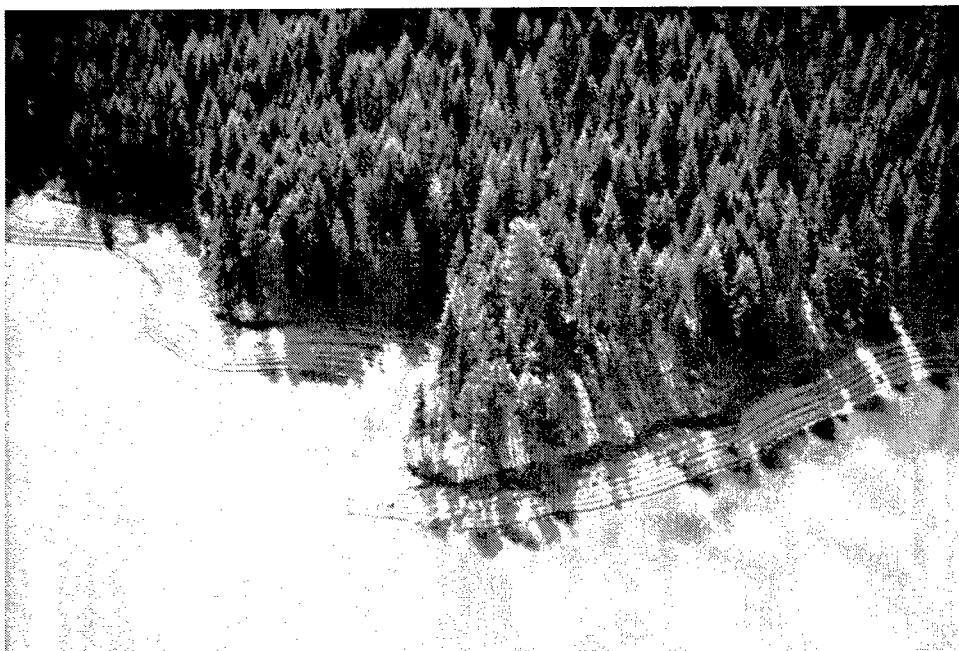
Figure 5. Example of wave impact along the shoreline, Dworshak Reservoir, Idaho

Although numerous factors influence the rate and occurrence of erosion, the primary cause of bank erosion is wave action (modified after Ebert 1989). During this study, wave action was the dominant process not only in occurrence but in extent of destruction as well (Figure 5). Wave action can be generated from wind, tectonism, and pool level fluctuation. Erodibility index of the soil and the slope of the surface also needs to be considered. Erosion exists in both zones of impact although reservoir fluctuations do not directly affect erosional processes or depositional processes of the indirect impact zone. Since most of the indirect impact zone is heavily forested, few geomorphological processes could be identified.

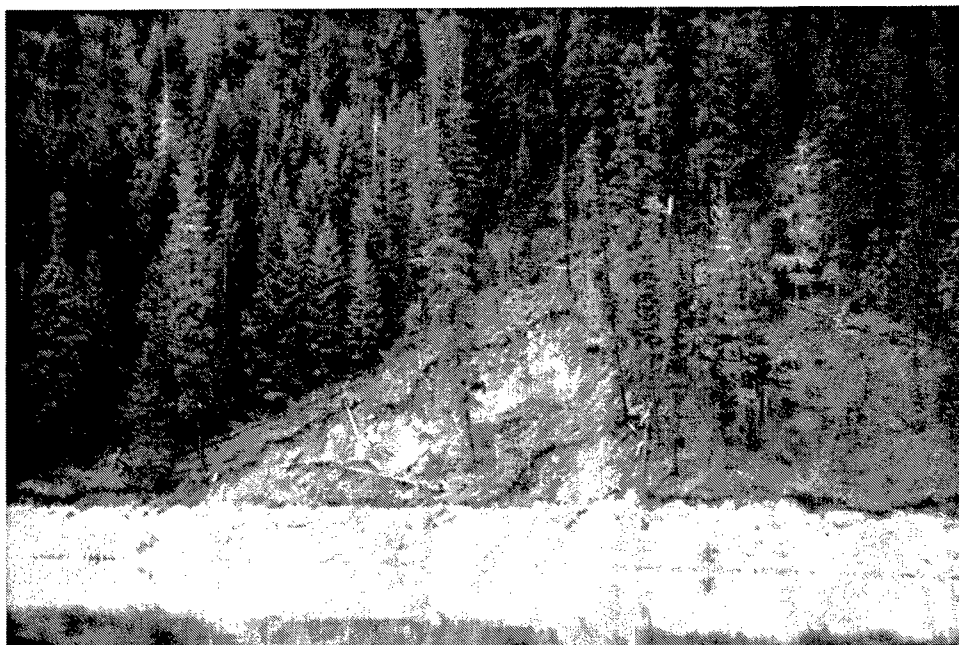
Figure 6. Mass failure in the high impact zone, Dworshak Reservoir, Idaho

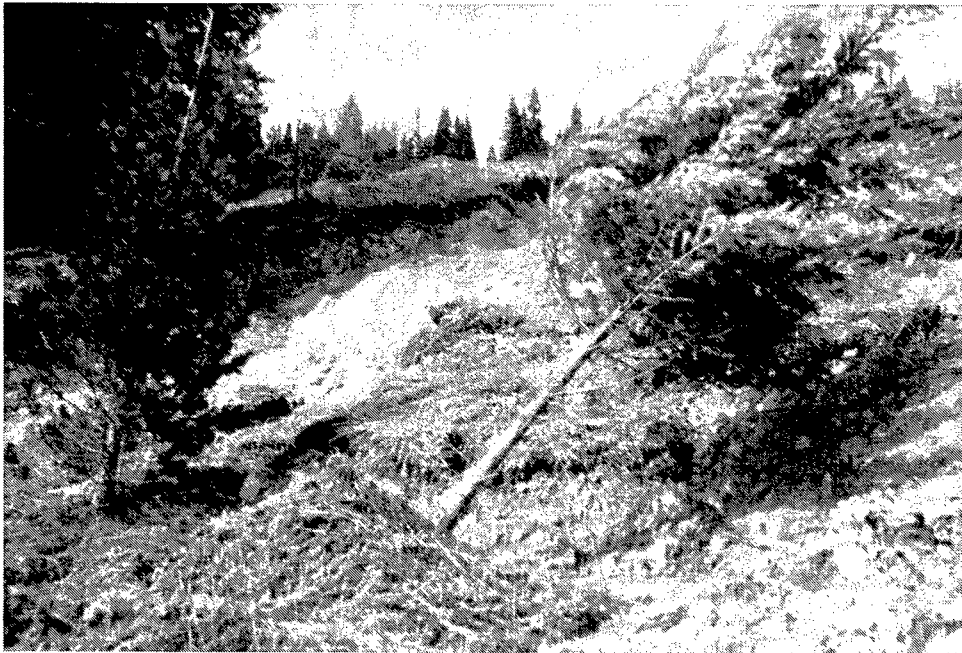
Figure 7. Downward movement of material (soil and vegetation) along the failure plane, Dworshak Reservoir, Idaho

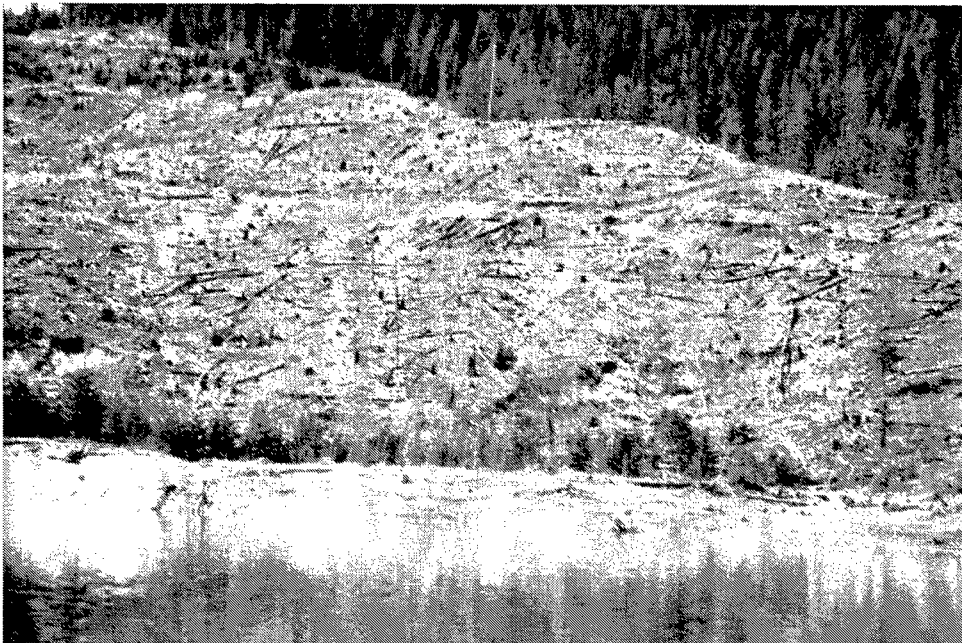
Figure 8. Logging in low impact zone, Dworshak Reservoir, Idaho

Forest practices, especially those associated with timber harvest and road construction, have increased mass wasting on already unstable slopes (Figure 8). Overland flow, identified as sheetwash in the Dworshak GIS, occurs on hillsides during a rainstorm when surface depression storage and either, in the case of prolonged rain, soil moisture storage or, with intense rain, the infiltration capacity of the soil are exceeded (modified after Morgan 1986). Soil loss from sheetwash varies according to velocity and turbulence of the flow and is more prevalent in areas with little or no vegetation. Gully erosion is another major geomorphic process affecting archaeological sites. Gullies are steep-sided stream courses which experience ephemeral flows during rainstorms. The width and depth of gullies vary. Due to their erratic behavior, a relationship between sediment discharge and runoff is difficult to establish. Existence of gullies is mainly attributed to excessive rainfall or extensive clearing of vegetation.

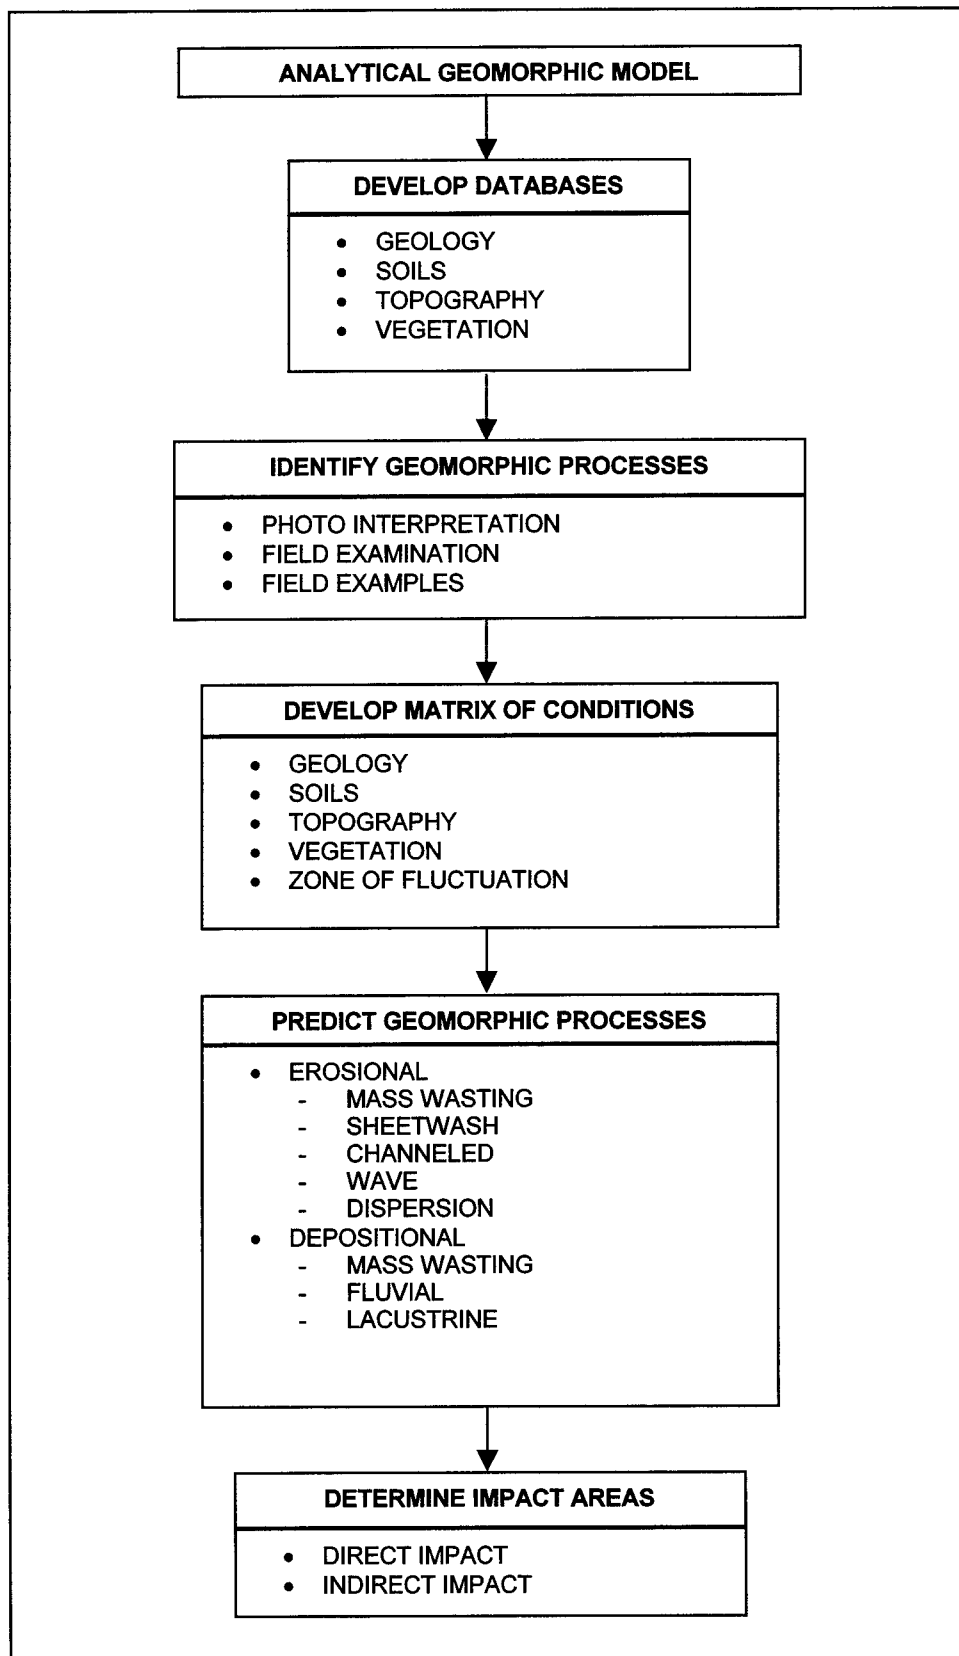
Figure 9. Sequential steps of an analytical geomorphic model

The analytical geomorphic model followed sequential steps in constructing a basic model that can be used in management of a reservoir (Figure 9). A database pertaining to the geomorphology was first developed. Geomorphic processes were then identified from interpretation of existing maps, aerial photography, and video photography of the reservoirs at an altitude of less than 304.8 m (1,000 ft) from a helicopter. The video photography was used during field investigations of the more pronounced mass failures. Aerial photographs were later scanned and interpreted for use in a GIS. Unfortunately, photographs of Dworshak Reservoir were distorted and linkage between photographs was not possible. However, the photographs exist as a separate and important part of the geologic and geomorphic database. After identification and delineation of geomorphic processes active in the reservoir areas, the next step in development of the analytical procedure is development of a matrix of site conditions in the form of a GIS.

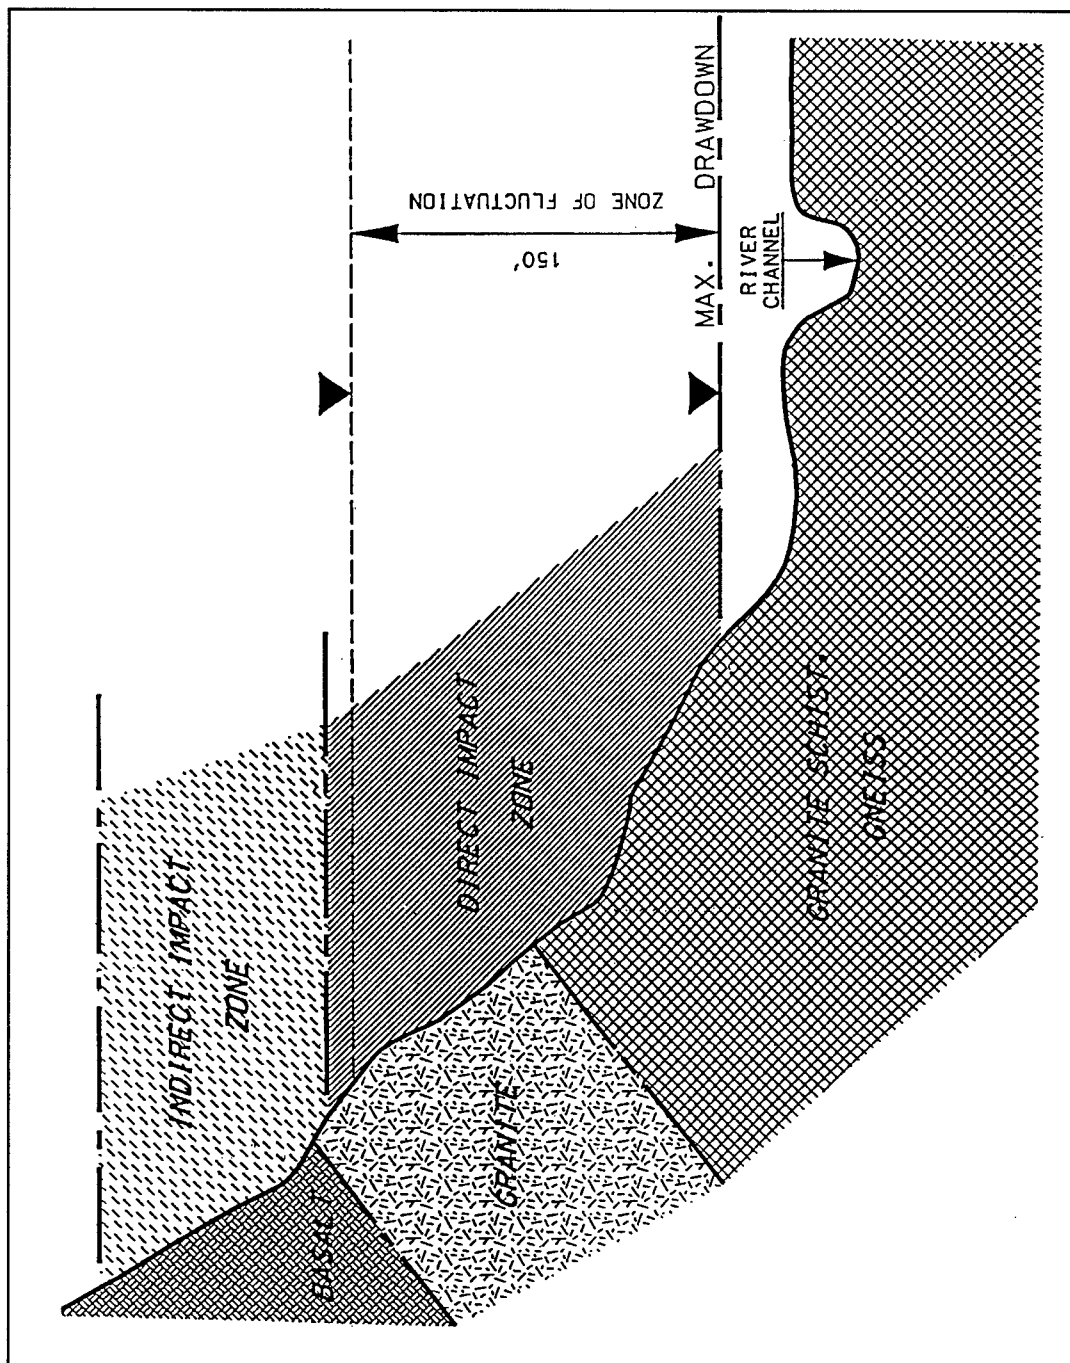
Figure 10. Division of study area into direct and indirect impact zones
